CRAFT POND DAM

NDI ID NO. PA-01103

PHASE I INSPECTION REPORT
NATIONAL DAM INSPECTION PROGRAM

JULY 1981

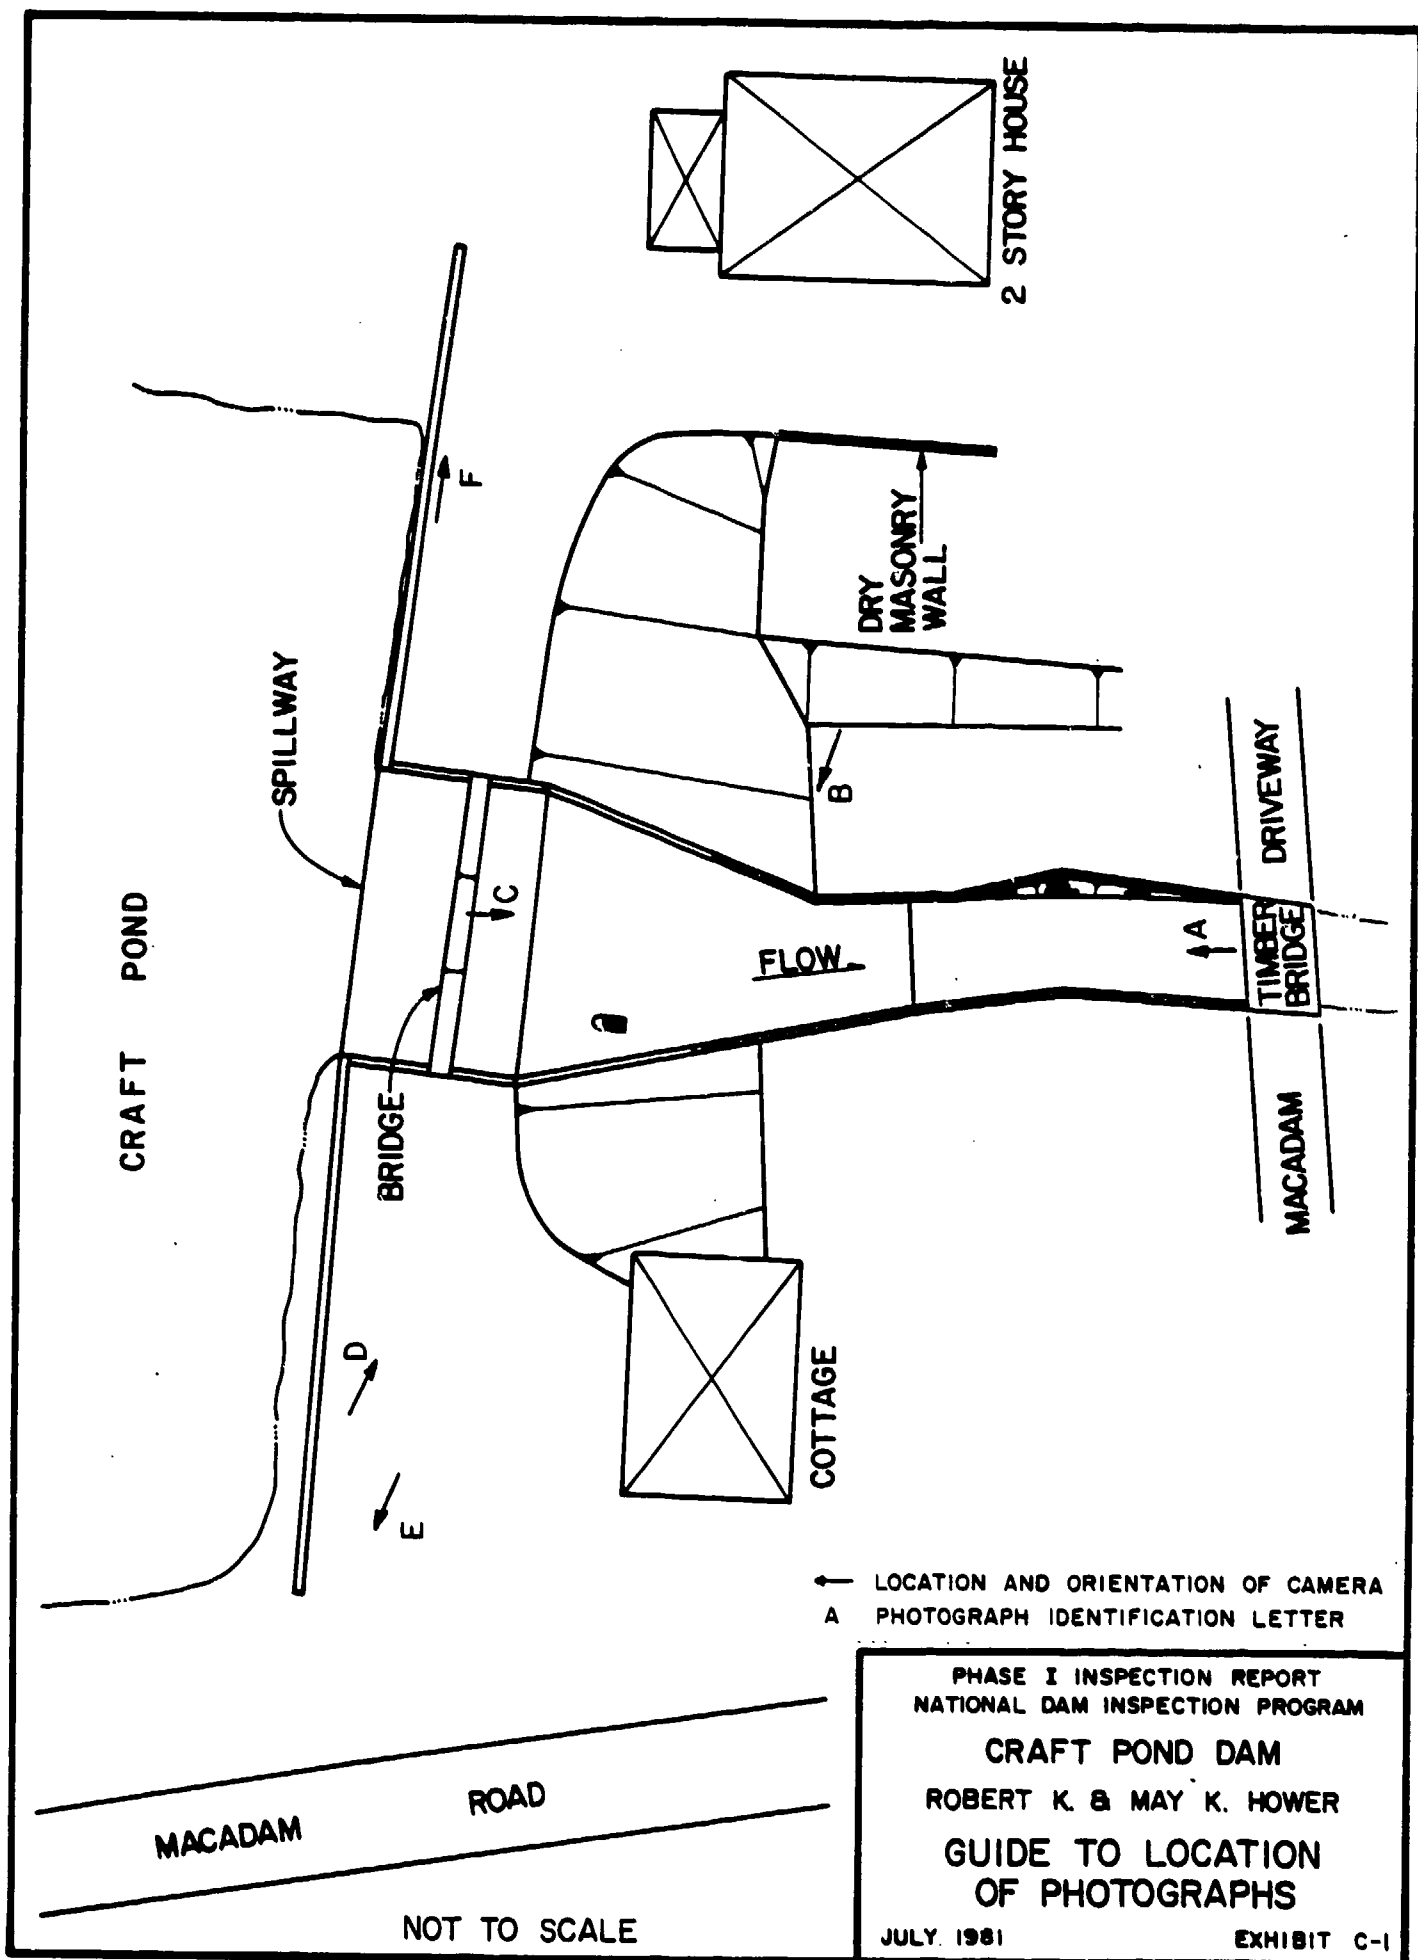
F. Left Abutment

b. Embankment. The embankment is in good condition. The grass covering the embankment is well maintained. There is one mature tree growing on the embankment to the right of the spillway (Photograph D). Two other mature trees are growing at the left abutment (Photograph F). As noted on Exhibit B-1, three burrowing animal holes were observed on the embankment. The Owner reported that two of these holes were dug out to remove snakes and never completely backfilled. There are several shrinkage cracks on the upstream concrete facing. Most of these cracks are repaired with mortar. There is a footing along the upstream concrete face that is sheared off at some locations (Photograph F). No seepage was observed at the dam.
